Flood Control Project Maintenance
2015 Structure Summary Report
Overall Unit and Item Ratings

Turlock Irrigation District Gomes Lake

Gomes Lake Pumping Plant

Pumping Plant Rating	A
Date of Inspection	07/23/2015
DWR Inspector	Pavel Kazi
Accompanied By	Tim Payne TID

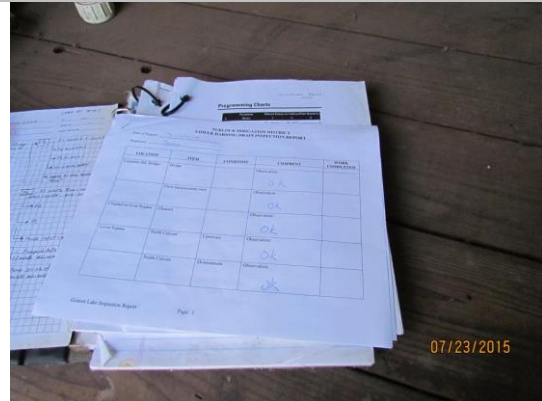
Photo 1 of 1 : ST_2015_NA0065_15_1_20150811_00021.jpg

LM Start	0.00	Rating **	A	Issue No.	1
LM End	0.00	Issue Type +	Ma	Location *	
Category	Pump Stations			GPS Latitude/Longitude	
				Start	End
Item	Operating Log			37.481567 °	37.481567 °
				-121.046617 °	-121.046617 °
DWR ID	DWR_NA0065_15_t_2012_1				
Action/Comments					
Inspector Comments: An operation log was present at the plant and the log was up to date.

View of the operating log.

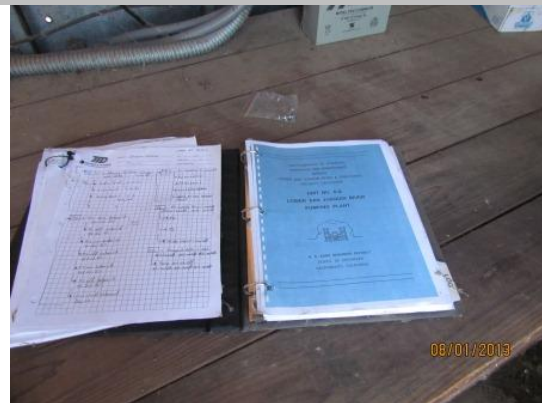
Photo 1 of 1 : ST_2015_NA0065_15_2_20150710_00002.jpg

LM Start	0.00	Rating **	A	Issue No.	2
LM End	0.00	Issue Type +	Ma	Location *	
Category	Pump Stations			GPS Latitude/Longitude	
				Start	End
Item	Operation & Maintenance Manual			37.481567 °	37.481567 °
				-121.046617 °	-121.046617 °
DWR ID	DWR_NA0065_15_t_2012_2				
Action/Comments					
Inspector Comments: The O&M manual was present at the plant.

View of the O&M manual inside the plant.

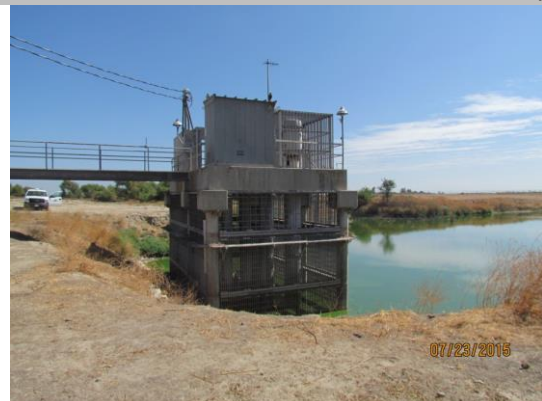
Photo 1 of 1 : ST_2015_NA0065_15_3_20150811_00022.jpg

LM Start	0.00	Rating **	A	Issue No.	3
LM End	0.00	Issue Type +	Ma	Location *	
Category	Pump Stations			GPS Latitude/Longitude	
				Start	End
Item	Plant Building			37.481567 °	37.481567 °
				-121.046617 °	-121.046617 °
DWR ID	DWR_NA0065_15_t_2012_3				
Action/Comments					
Inspector Comments: The plant building appeared to be in good structural condition with no major visible concrete damage.

View of the pumping plant.

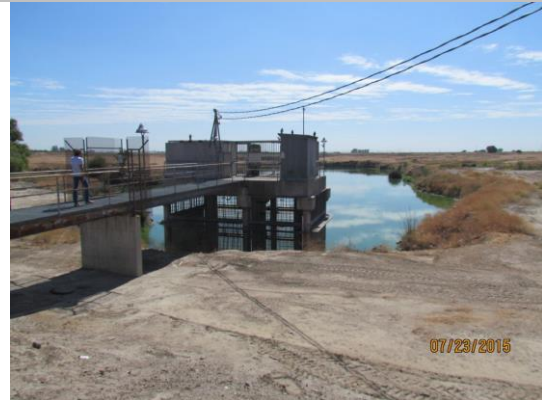
Photo 1 of 1 : ST_2015_NA0065_15_5_20150811_00023.jpg

LM Start	0.00	Rating **	A	Issue No.	5
LM End	0.00	Issue Type +	Ma	Location *	
Category	Pump Stations			GPS Latitude/Longitude	
				Start	End
Item	Safety			37.481567 °	37.481567 °
				-121.046617 °	-121.046617 °
DWR ID	DWR_NA0065_15_t_2012_5				
Action/Comments					
Inspector Comments: No significant safety hazard was observed at the plant during inspection. The lights were in working condition along with guard rails around the structure.

View of the guard rails around the pumping plant.

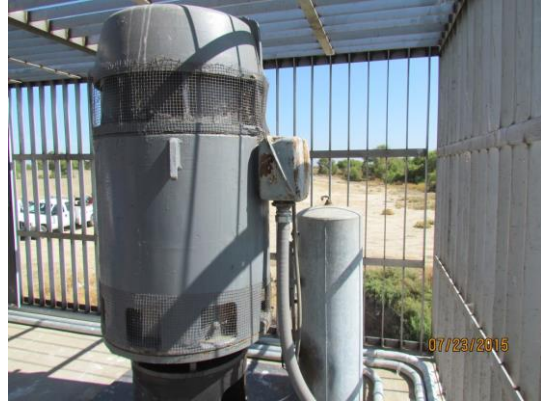
Photo 1 of 3 : ST_2015_NA0065_15_7_20150811_00024.jpg

LM Start	0.00	Rating **	A	Issue No.	7
LM End	0.00	Issue Type +	Ma	Location *	
Category	Pump Stations			GPS Latitude/Longitude	
				Start	End
Item	Pumps			37.481567 °	37.481567 °
				-121.046617 °	-121.046617 °
DWR ID	DWR_NA0065_15_t_2012_7				
Action/Comments					
Inspector Comments: All pumps were properly maintained and lubricated and they were periodically tested before the high water season.

View of one of the pumps.

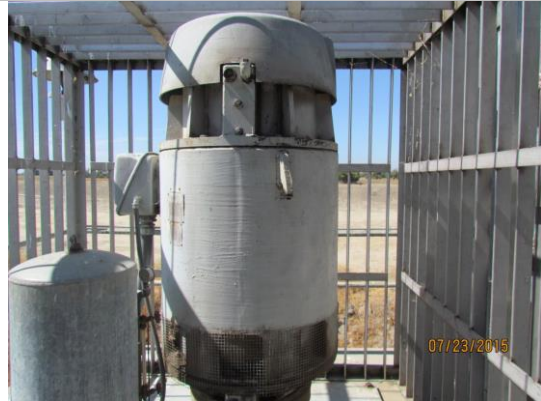
Photo 2 of 3 : ST_2015_NA0065_15_7_20150811_00025.jpg

View of another pump.

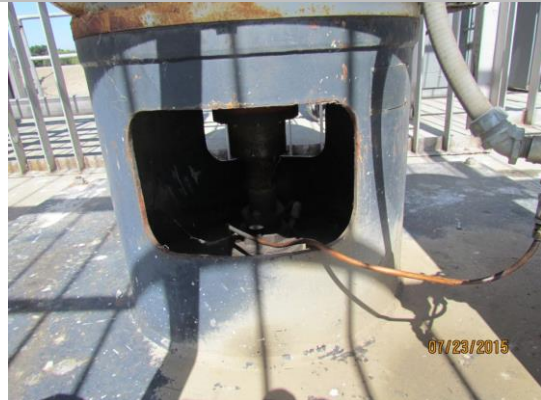
Photo 3 of 3 : ST_2015_NA0065_15_7_20150811_00026.jpg

View of bottom of a pump.

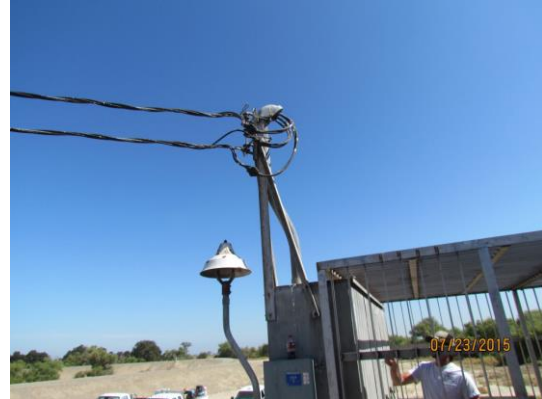
Photo 1 of 1 : ST_2015_NA0065_15_8_20150811_00027.jpg

LM Start	0.00	Rating **	A	Issue No.	8
LM End	0.00	Issue Type +	Ma	Location *	
Category	Pump Stations			GPS Latitude/Longitude	
				Start	End
Item	Power			37.481567 °	37.481567 °
				-121.046617 °	-121.046617 °
DWR ID	DWR_NA0065_15_t_2012_8				
Action/Comments					
Inspector Comments: The power source for this plant was delivered by the power grid rather than a generator and it appeared to be adequate and reliable.

View of the power source at the plant.

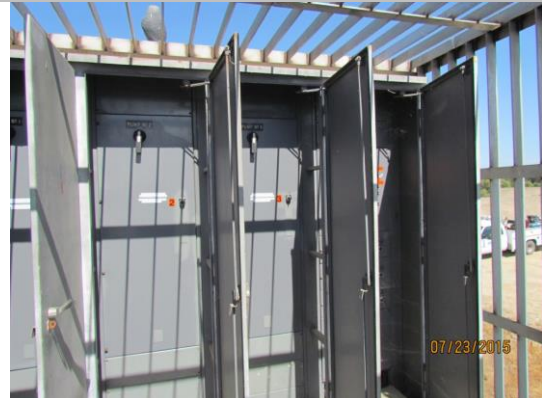
Photo 1 of 1 : ST_2015_NA0065_15_11_20150811_00029.jpg

LM Start	0.00	Rating **	A	Issue No.	11
LM End	0.00	Issue Type +	Ma	Location *	
Category	Pump Stations			GPS Latitude/Longitude	
				Start	End
Item	Pump Control Systems			37.481567 °	37.481567 °
				-121.046617 °	-121.046617 °
DWR ID	DWR_NA0065_15_t_2012_11				
Action/Comments					
Inspector Comments: The pump control system was operational and appeared to be free of any damage or corrosion.

View of the pump control boxes.

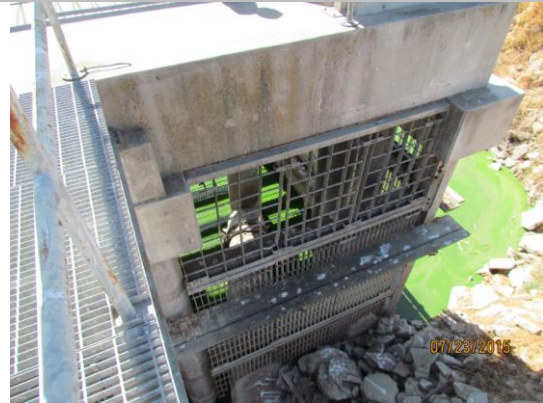
Photo 1 of 1 : ST_2015_NA0065_15_12_20150811_00030.jpg

LM Start	0.00	Rating **	A	Issue No.	12
LM End	0.00	Issue Type +	Ma	Location *	
Category	Pump Stations			GPS Latitude/Longitude	
				Start	End
Item	Sumps/Wet Well			37.481567 °	37.481567 °
				-121.046617 °	-121.046617 °
DWR ID	DWR_NA0065_15_t _ 2012_12				
Action/Comments					
Inspector Comments: The wet well was clear of excessive debris and other obstructions.

View of the wet well.

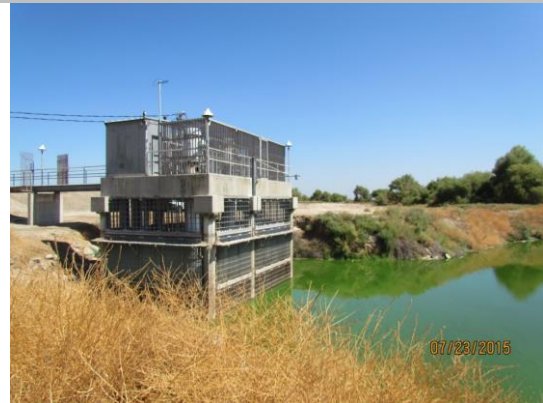
Photo 1 of 1 : ST_2015_NA0065_15_13_20150811_00031.jpg

LM Start	0.00	Rating **	A	Issue No.	13
LM End	0.00	Issue Type +	Ma	Location *	
Category	Pump Stations			GPS Latitude/Longitude	
				Start	End
Item	Trash Racks			37.481567 °	37.481567 °
				-121.046617 °	-121.046617 °
DWR ID	DWR_NA0065_15_t_2012_13				
Action/Comments					
Inspector Comments: The trash racks were free of debris and appeared to be maintained properly.

View of the trash racks.

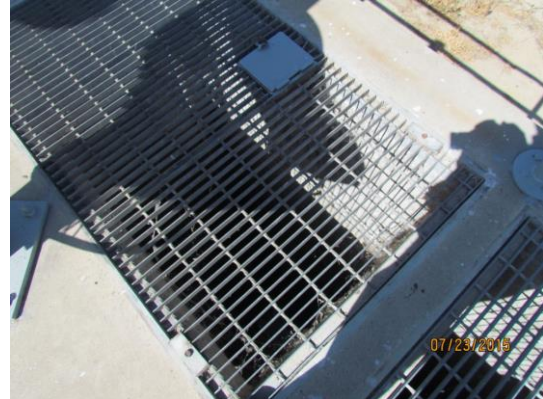
Photo 1 of 1 : ST_2015_NA0065_15_15_20150811_00032.jpg

LM Start	0.00	Rating **	A	Issue No.	15
LM End	0.00	Issue Type +	Ma	Location *	
Category	Pump Stations			GPS Latitude/Longitude	
				Start	End
Item	Sluice / Slide Gates			37.481567 °	37.481567 °
				-121.046617 °	-121.046617 °
DWR ID	DWR_NA0065_15_t_2012_15				
Action/Comments					
Inspector Comments: The slide gates were free of any debris and appeared to be in good working condition.

View of the slide gate on the outlet structure.

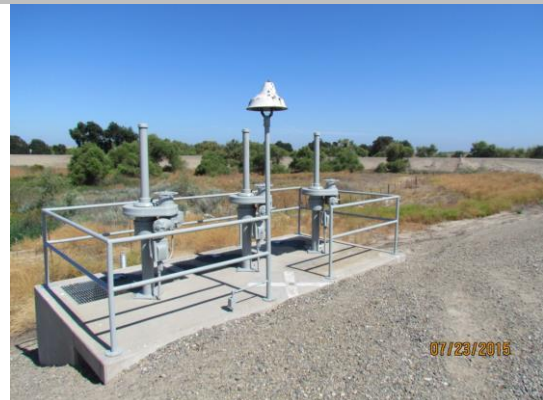
Photo 1 of 1 : ST_2015_NA0065_15_17_20150811_00033.jpg

LM Start	0.00	Rating **	A	Issue No.	17
LM End	0.00	Issue Type +	Ma	Location *	
Category	Pump Stations			GPS Latitude/Longitude	
				Start	End
Item	Manual Gate Operators			37.481567 °	37.481567 °
				-121.046617 °	-121.046617 °
DWR ID	DWR_NA0065_15_t_2012_17				
Action/Comments					
Inspector Comments: Manual gate operators appeared to be operational and capable of opening and closing the gate properly.

View of the manual gates.

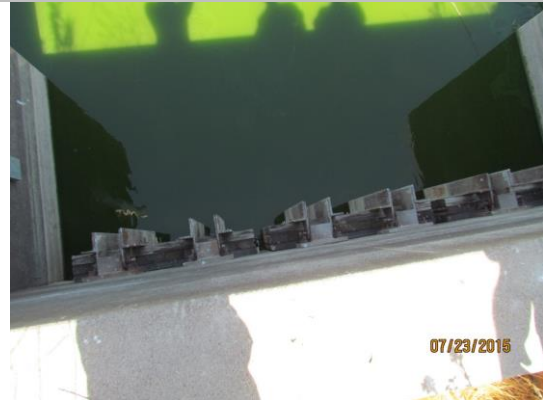
Photo 1 of 1 : ST_2015_NA0065_15_19_20150811_00034.jpg

LM Start	0.00	Rating **	A	Issue No.	19
LM End	0.00	Issue Type +	Ma	Location *	
Category	Pump Stations			GPS Latitude/Longitude	
				Start	End
Item	Flap Gates			37.481567 °	37.481567 °
				-121.046617 °	-121.046617 °
DWR ID	DWR_NA0065_15_t_2012_19				
Action/Comments					
Inspector Comments: The flap gates appeared to be in good working condition and capable of performing as intended.

View of the flap gates.

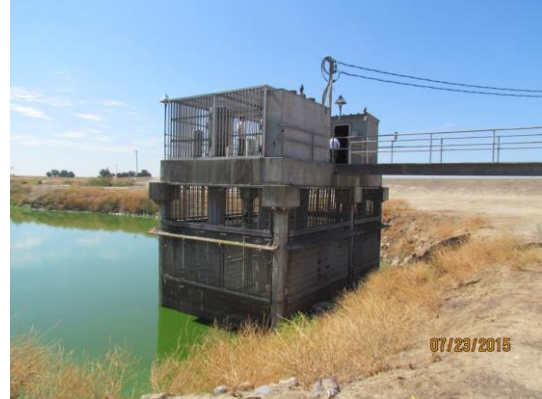
Photo 1 of 1 : ST_2015_NA0065_15_21_20150811_00035.jpg

LM Start	0.00	Rating **	A	Issue No.	21
LM End	0.00	Issue Type +	Ma	Location *	
Category	Pump Stations			GPS Latitude/Longitude	
				Start	End
Item	Security Fencing			37.481567 °	37.481567 °
				-121.046617 °	-121.046617 °
DWR ID	DWR_NA0065_15_t_2012_21				
Action/Comments					
Inspector Comments: The security fencing appeared to be in good condition and should provide protection against unauthorized access.

View of the steel cage around the pumps on the structure.

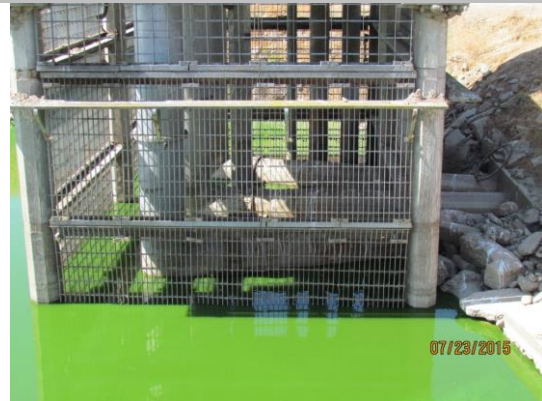
Photo 1 of 1 : ST_2015_NA0065_15_22_20150811_00036.jpg

LM Start	0.00	Rating **	A	Issue No.	22
LM End	0.00	Issue Type +	Ma	Location *	
Category	Pump Stations			GPS Latitude/Longitude	
				Start	End
Item	Intake and Discharge Pipes			37.481567 °	37.481567 °
				-121.046617 °	-121.046617 °
DWR ID	DWR_NA0065_15_t_2012_22				
Action/Comments					
Inspector Comments: The intake and discharge pipes appeared to be free of any breaks, holes or cracks.

View of the intake pipes.
